BEFORE THE NATIONAL GREEN TRIBUNAL, SOUTHERN ZONE,  
CHENNAI  
APPLICATION No.8 OF 2016 etc

ENVIRONMENTAL IMPACTS OF COAL ASH  
POLLUTION ON ENNORE CREEK AND  
SURROUNDING AREAS OF  
NORTH CHENNAI THERMAL POWER STATION  
(NCTPS)  
ENNORE, CHENNAI

EXPERT COMMITTEE REPORT OF

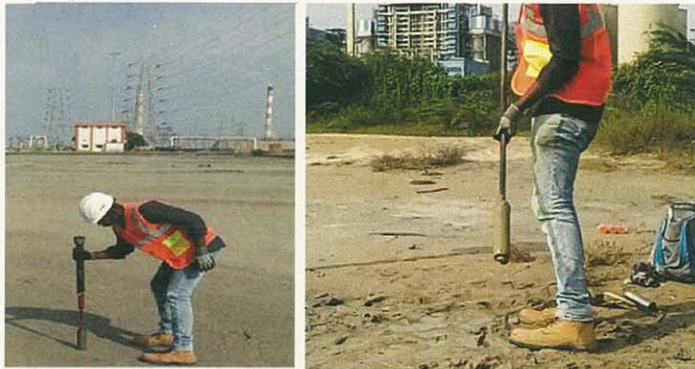
The in-situ dry bulk density of the core samples at different depths and sites ranged from 0.990 g/cc to 1.801 g/cc thus indicating different levels of compaction of fly ash in the field. The average bulk density of different samples is about 1.341 g/cc. Hence, 8.19 Million ton of fly ash would be in volume terms vary based on the level of looseness or consolidation in the field.

Figure 4. Undisturbed core samples collected using slide hammer auger (18 locations)

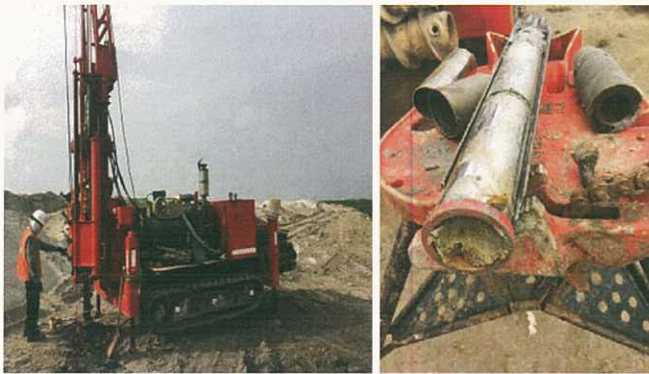
Figure 5. Undisturbed core samples collected using Hollow Stem Auger

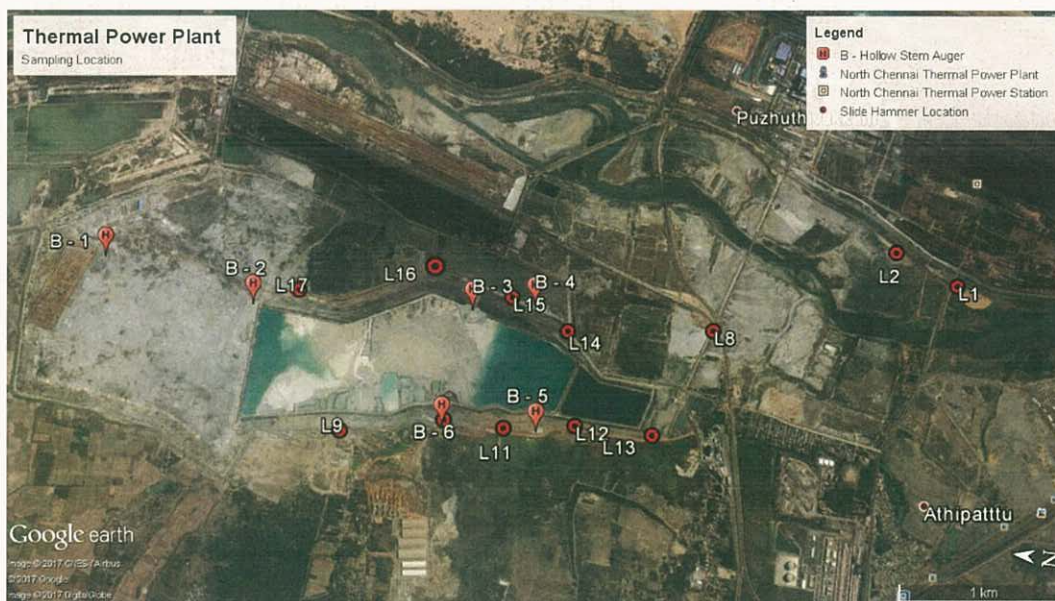
Figure 6. Undisturbed fly ash core sample collection locations

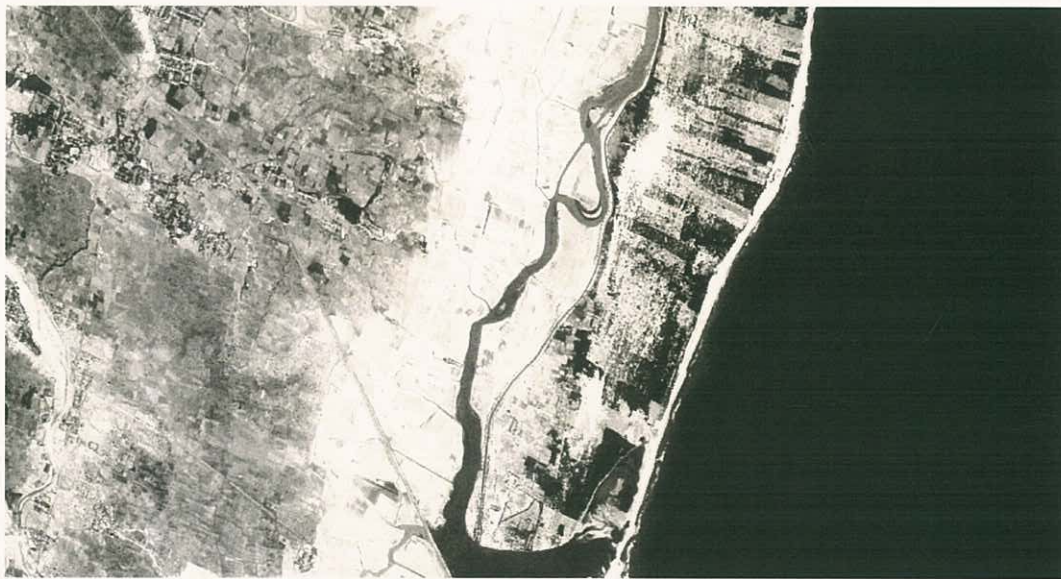
Figure 8. High resolution aerial imagery of the region acquired from the declassified imagery of NASA acquired during the 1960's (most probably 1965)

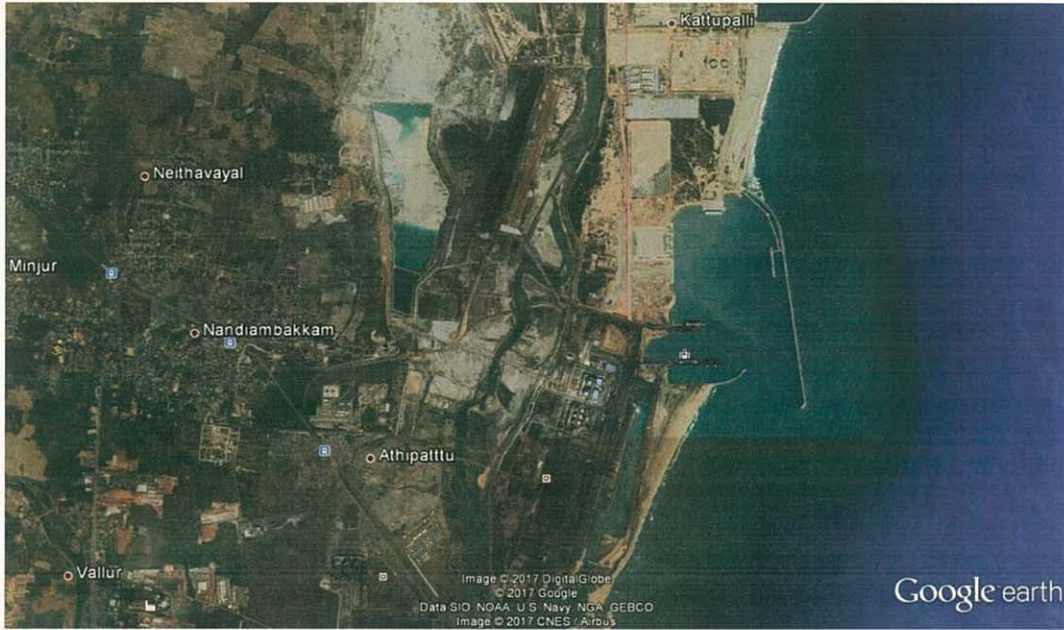
Figure 9. High resolution satellite imagery of the region from google earth (between February and March 2017)

The recent google earth imagery as well as the field visits clearly shows the extent of fly ash spill in the region and the devastation it is causing to the sensitive marshland ecosystem.
