POWERing Pollution

The Environmental Impacts
of Thermal Power Stations
and Mining Operations in
Neyveli & Parangipettai

August 2023

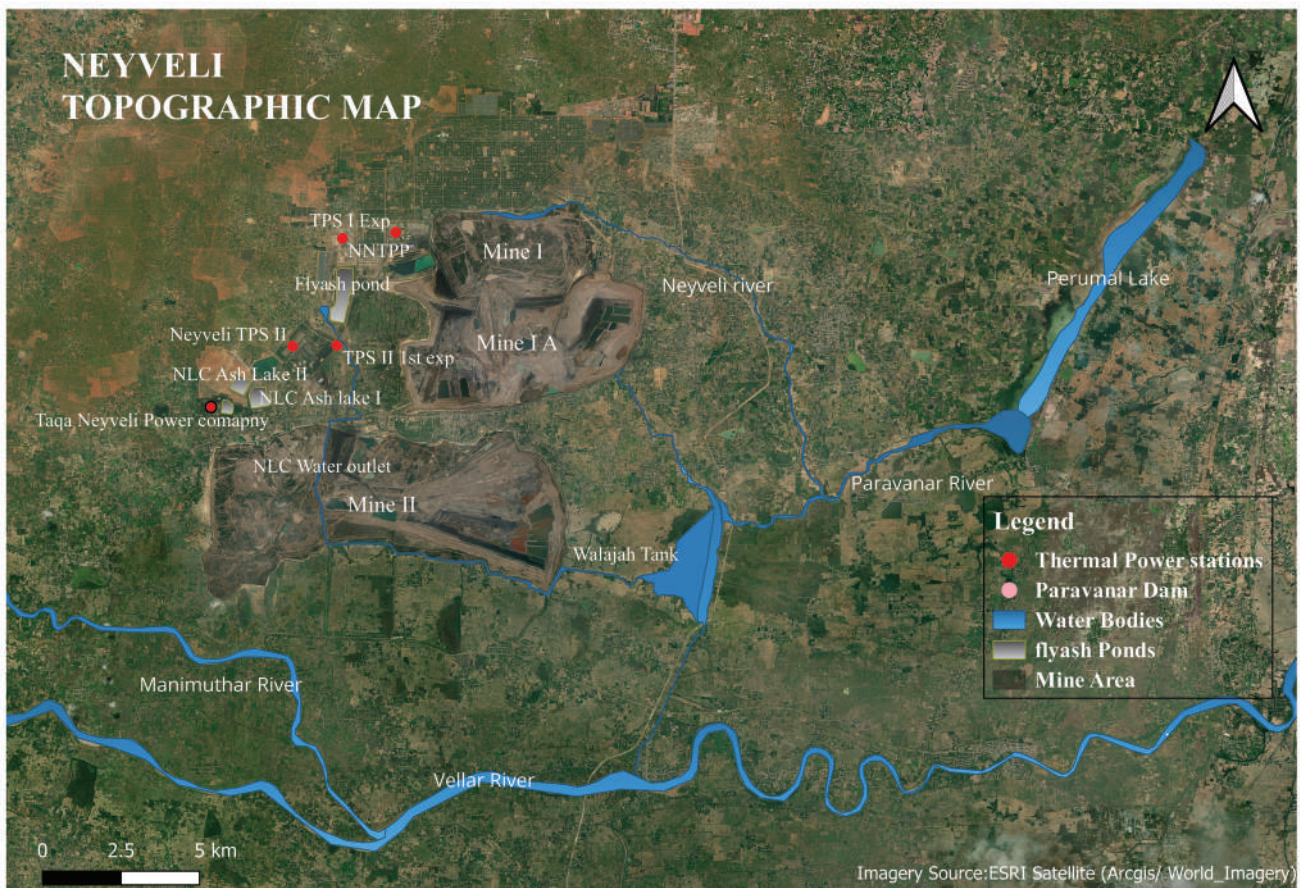
Figure 1: Map showing thermal power plants and open cast mines operating in the Neyveli region

See Map at Figure 1 for the location and layout of the power plants and the mines.

See Map at Figure 1 for the location of the mines as well as the power plants.

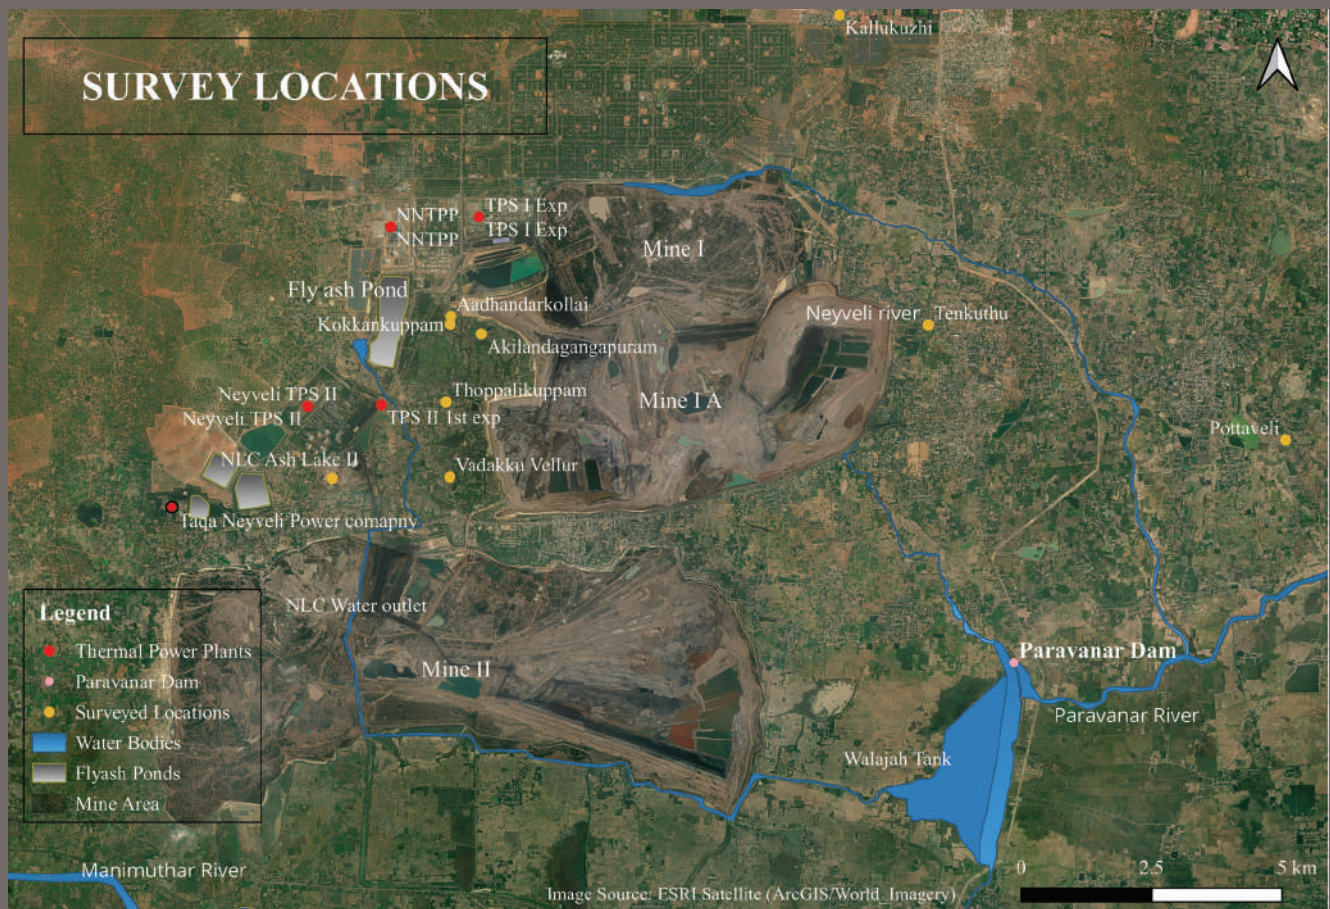
Figure 2: Villages where questionnaire survey and FoGD was conducted

To understand the experiences of the communities impacted by the pollution in the area, and to have them directly talk about their own problems, we conducted a questionnaire based survey in seven villages in the Neyveli area. These seven villages were selected to give a geographical spread around the NLC TPSs and mines. The survey consisted of village level Focus Group Discussions (FoGD) in each of these seven villages, and individual interviews with 101 individuals in these villages. The list of the villages surveyed is given in Table 4, and the Map in Figure 2 shows their locations.

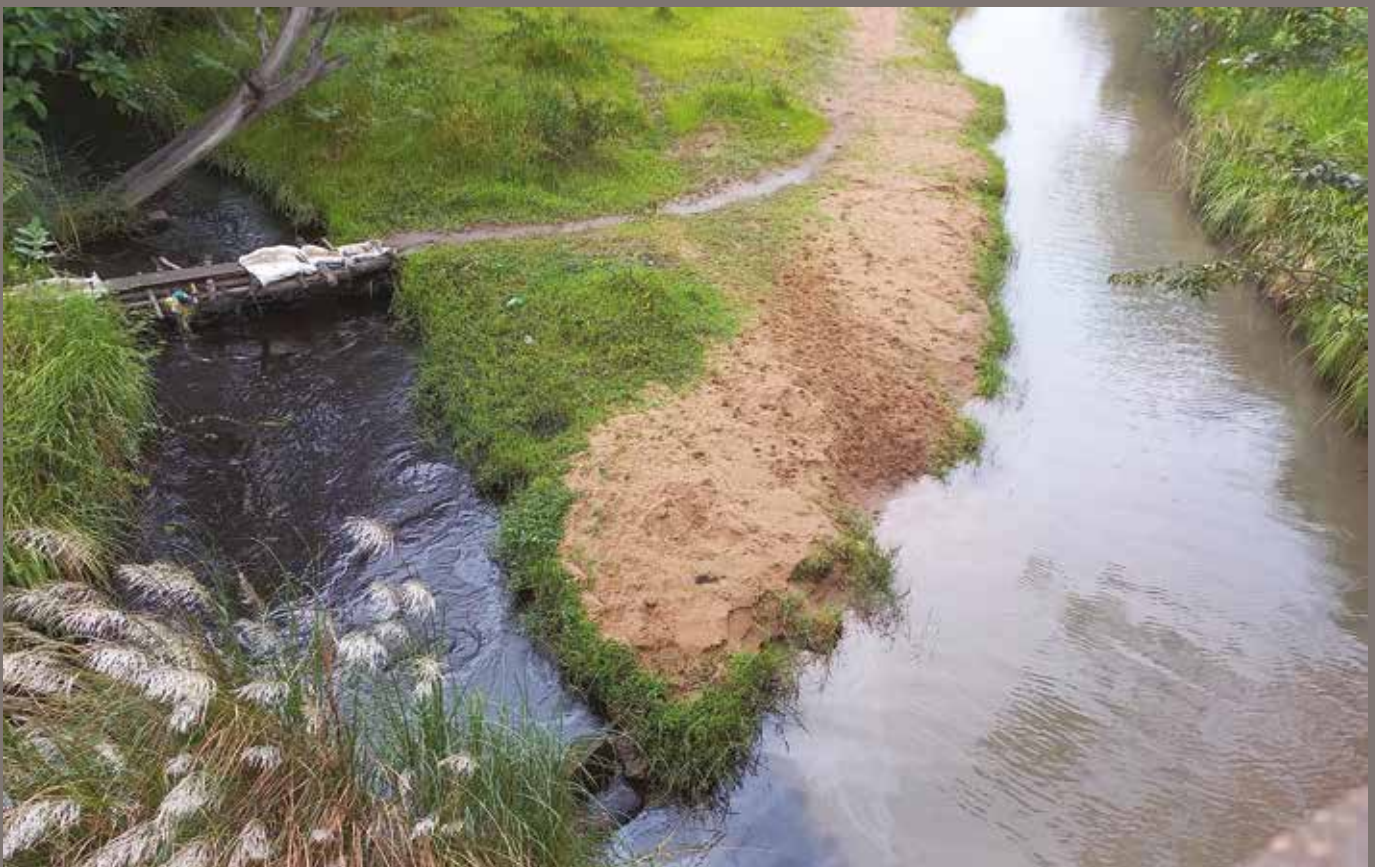
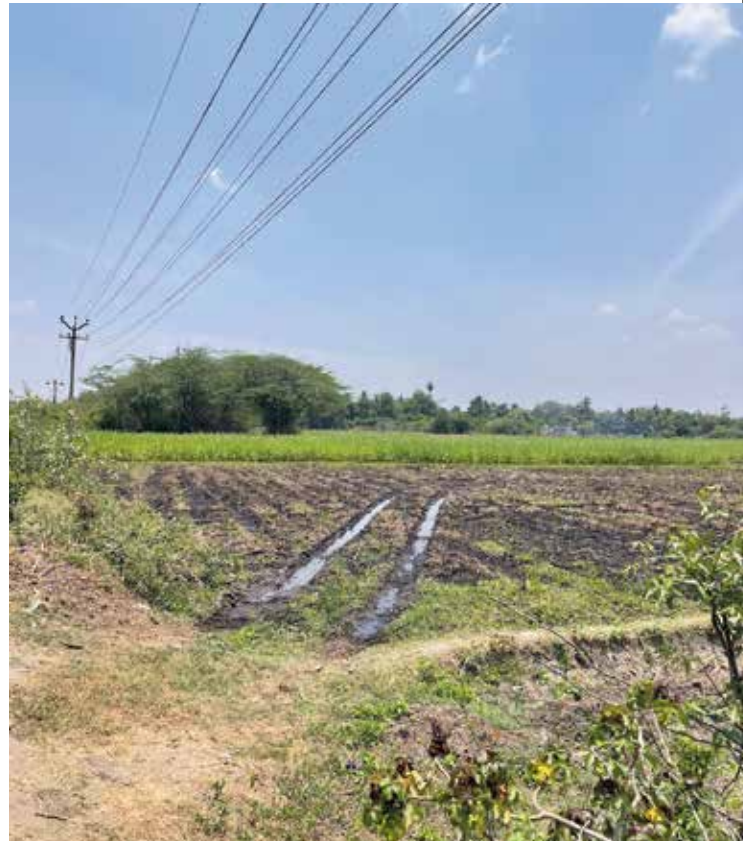
Figure 4: Water that is used to irrigate the fields and is the cause of people's skin disease as they walk on the field.

In Vadakku Vellur, (April 2023) there was one such stream which reportedly was carrying water from Neyveli TPS II and Neyveli New TPS. As per the local people, this water flows to the Moopeneri lake and the water from here is used for irrigation. As per them, earlier 96 acres of this lake was accessible by the people, but now the accessible part has reduced to merely 1-2 acres. They informed the team that the water is now so polluted that not even insects can survive in it. The cattle also do not drink this water. Even the yield from fields irrigated with this water has reduced to a great extent and the food made from this yield tastes sour. When people sell this yield, they reportedly now fetch Rs. 300-350 less for a sack of rice than what they used to get. They report that they don't consume their produce themselves and have to purchase it from elsewhere. They said more than half the people have skin issues because they have to walk in the polluted water laden fields (Figure 4). It is not even easy to extract groundwater, as the water levels have gone down to 700-800 ft. Water testing from the stream done as part of this study (Location R2 S3) reveals high turbidity and elevated Selenium levels.

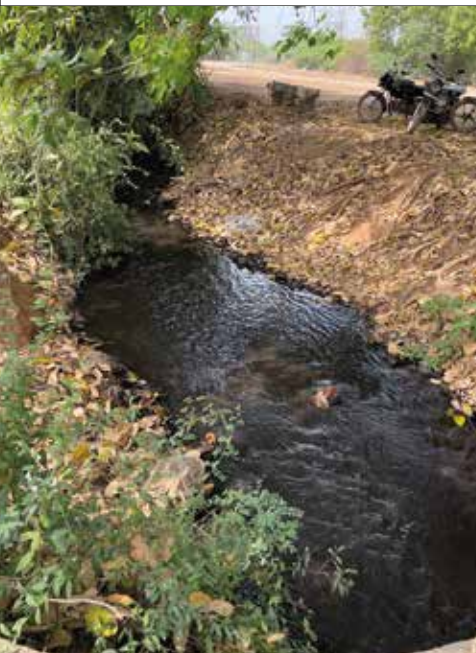
Figure 5: Stream reportedly carrying water from Neyveli TPS I EXP.

The team saw another stream which local people informed as originating from the Neyveli TPS I EXP. As informed, this water like other streams carrying water from other TPSs carries lignite washed water, boiler water and water from the coal stockyard of the TPS (Figure 5). A little further down the stream small bunds were seen, as locals informed, people have constructed these bunds to arrest the lignite particles mixed in the water. After collection, the local people sell this lignite (Figure 6). The stream meets the Walajah lake. Water sampling of this stream (Location R2 S7) revealed heavy contamination with high turbidity, hardness, Calcium, Magnesium and Selenium levels.

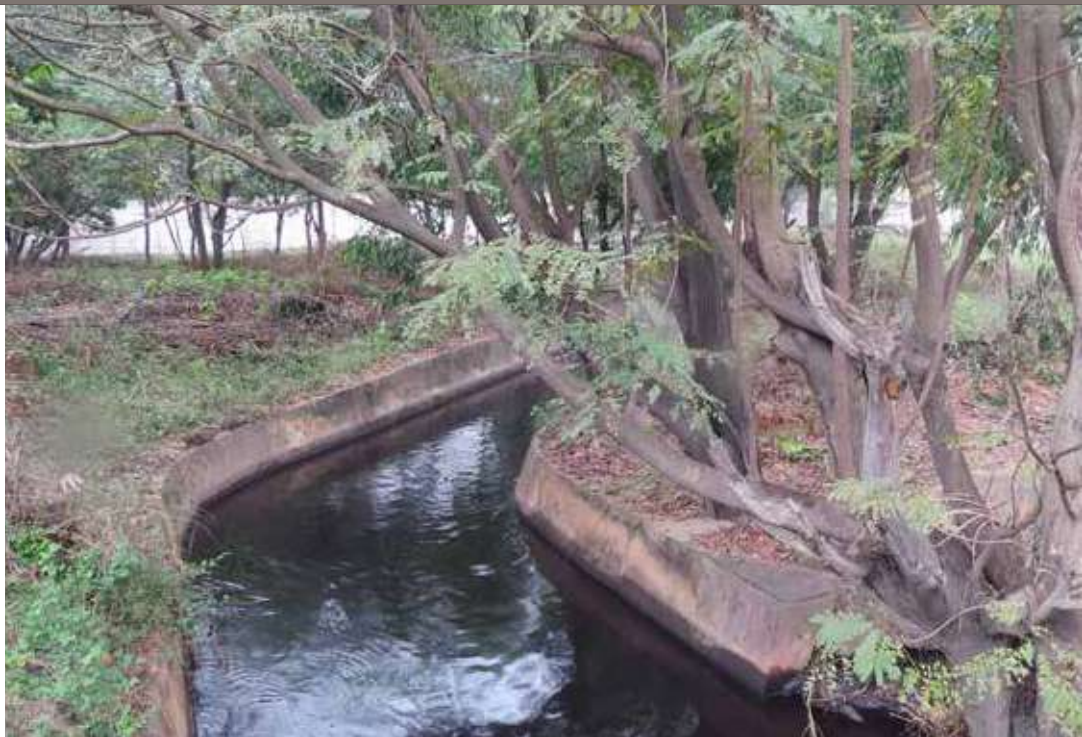
Figure 7: Effluent directly discharged from NLC TPS II with plant boundary visible in the background.

In the visit made in December 2022, the study team observed a stream with heavily polluted water coming straight out of Neyveli TPS II premises. The water was dark and had oil floating on it. TPS II plant boundary wall was observed in the background of the stream (Figure 7). The fact that it is channelized also indicates that it is designed and intended as an effluent channel. This water is being discharged directly into the environment.

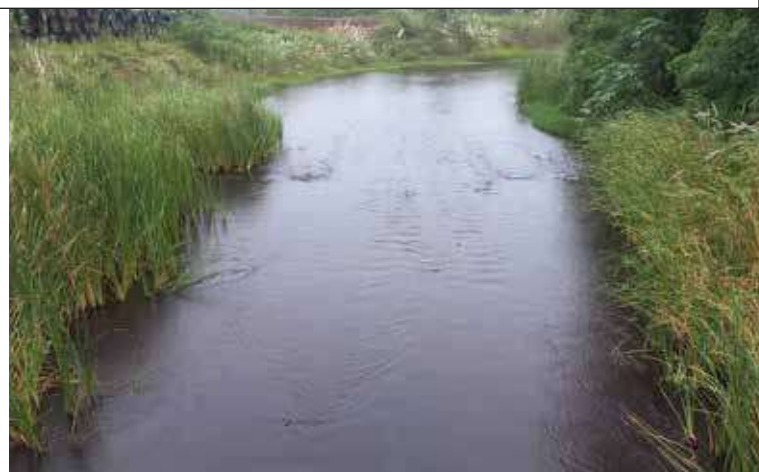
Figure 9: Stream carrying discharge from all TPS.

The study team noted a stream carrying discharge that was dark black in colour at yet another location. The team was informed by reliable sources that this stream is carrying discharge from several of the power plants coming together (Figure 9). The water from this point was sampled and tested in both the rounds of water testing (R1-L5 and R2 -S2) and was found to be seriously contaminated with high TSS in violation of limits, and presence of Mercury, Selenium, Fluoride, Iron, Magnesium, Silicon, Aluminium in high concentrations.

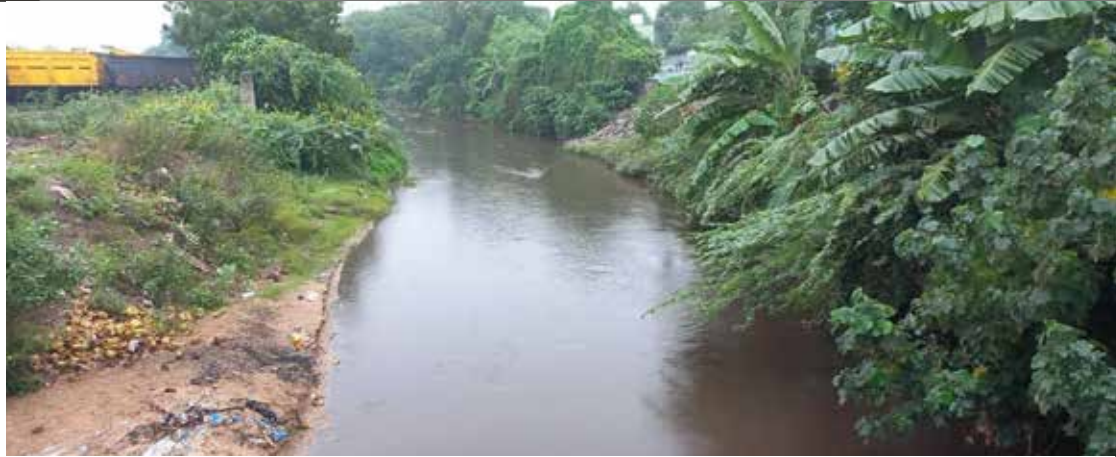
Figure 10: Polluted stream opposite Mine II gate.

The team visited a location in front of the gate of Mine 2, where it saw a highly polluted stream which the team was informed by reliable sources was carrying discharge from the mine 2 (Figure 10).

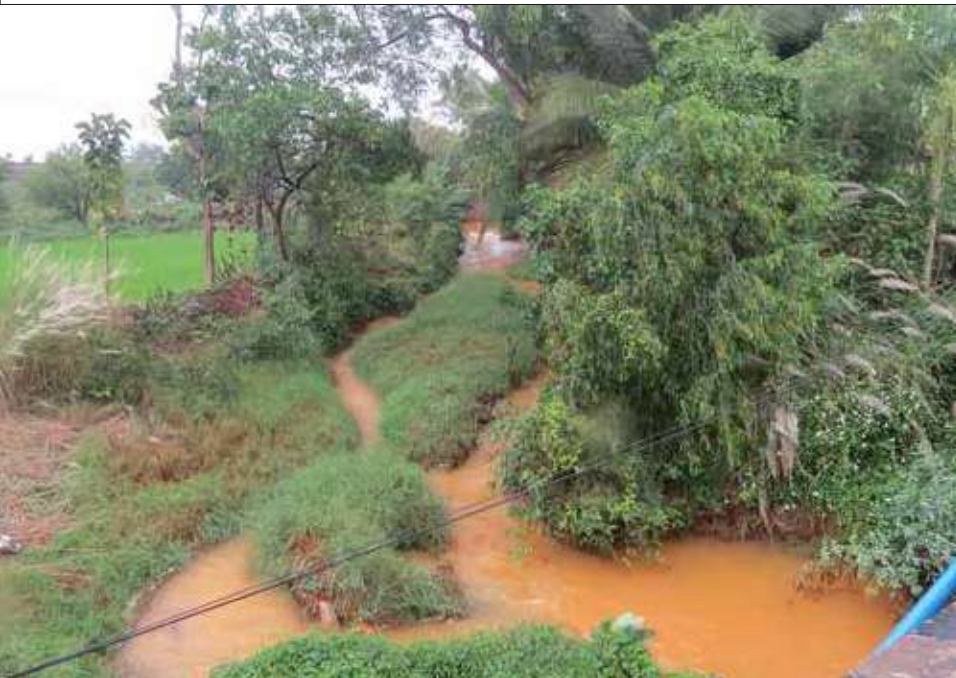
Figure 11: Brown-Yellow colour of the discharge stream from Mine 1 and 1A.

At another location where a discharge stream from Mine IA was observed, the team was informed that some discharge from Mine I is also mixed with this. The colour of the stream was yellow-brown which could indicate either high silt, but could also be indicative of acidic mine water discharge (Figure 11). As informed by the locals, this goes all the way to the Bay of Bengal. Water samples some distance downstream from this point had been collected for testing (R2 - S 1), and the test results showed the water to be uncontaminated. However, the sampling was done a few months after this field observation had been made. A more regular sampling and testing of this discharge is recommended.

The discharges from NLC mines observed are in clear violation of EPA rules and the EC conditions that mandate the *“industrial wastewater to be collected, treated so as to conform to the standards prescribed under GSR 422 (E) dated 19 March 1993 and 31st December 1993 before discharge.”*³⁶

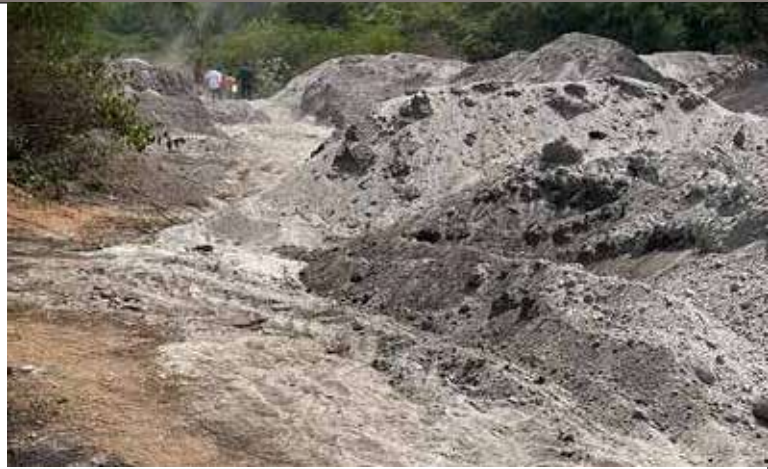
Figure 12: Ash dumped near the central water store.

During the field visit in Neyveli in April 2023, near the central water store where reportedly all the chemical laden, untreated water used to clean all the equipment comes, huge amounts of fly ash was seen dumped on the ground (Figure 12). The local person told the team that it was deposited by Neyveli TPS I EXP.

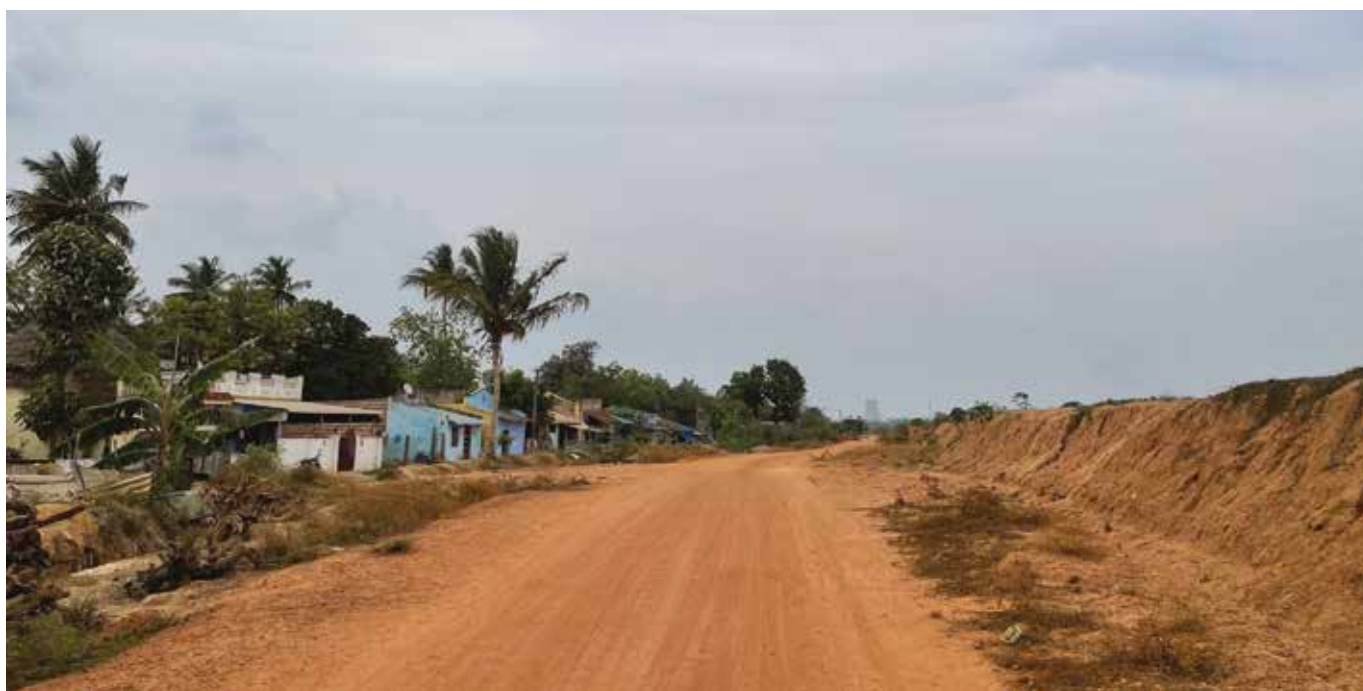
Figure 14: A kutchra road separating the homes of the people and Mine I boundary.

The rampant dust pollution observed in the village adjoining the Mine I very clearly shows that dust suppression measures are not adequately undertaken by Mine I.

It may be highlighted that the water testing of bore water from this village, used for drinking and domestic use by the people, showed alarmingly high levels of mercury and other pollutants. People also reported several serious ailments that are prevalent in the community here.

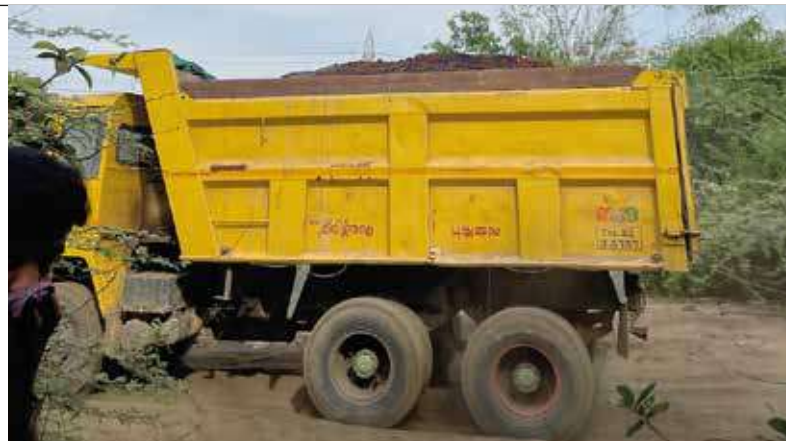
Figure 15: Uncovered trucks carrying the residue to an unidentified location.

While visiting the discharge stream reportedly carrying discharges from TPS II and ash pond of TPS II, a few uncovered trucks were seen carrying a mixture to an unknown location (Figure 15). The local people informed that the trucks were carrying a residue that is left after combustion of lignite for electricity generation. This residue consists of sand, ash and some lignite particles. They informed that the residue is collected, transported and then illegally dumped in some location not exactly known to them.

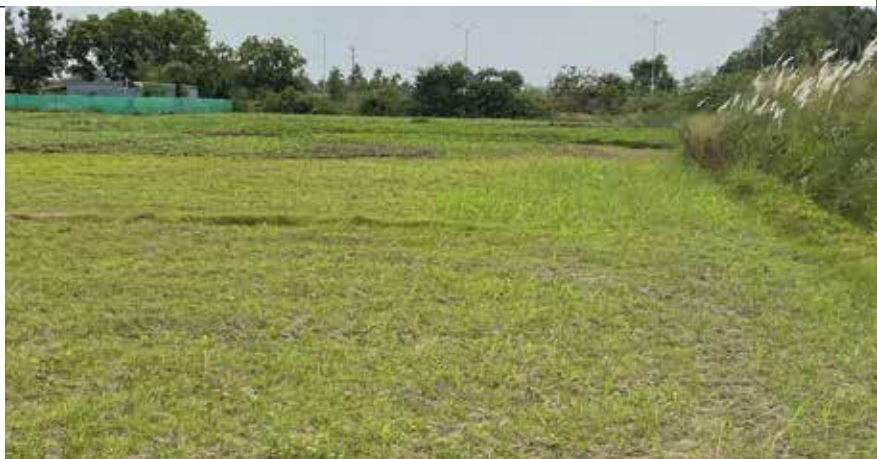
Figure 17: Agricultural patch of land that bore no yield.

Another patch of agricultural land was seen with ash dust in the soil (Figure 17). The locals reported that this agricultural land bore no yield. Soil sampling of this location revealed soil with low pH and serious contamination with high Selenium.
